# Geotechnical Investigation Report

Project  
**Ausgrid Underground Cable Project  
Alexandria to Kingsford**

Report No  
**14777-GR-2-1**

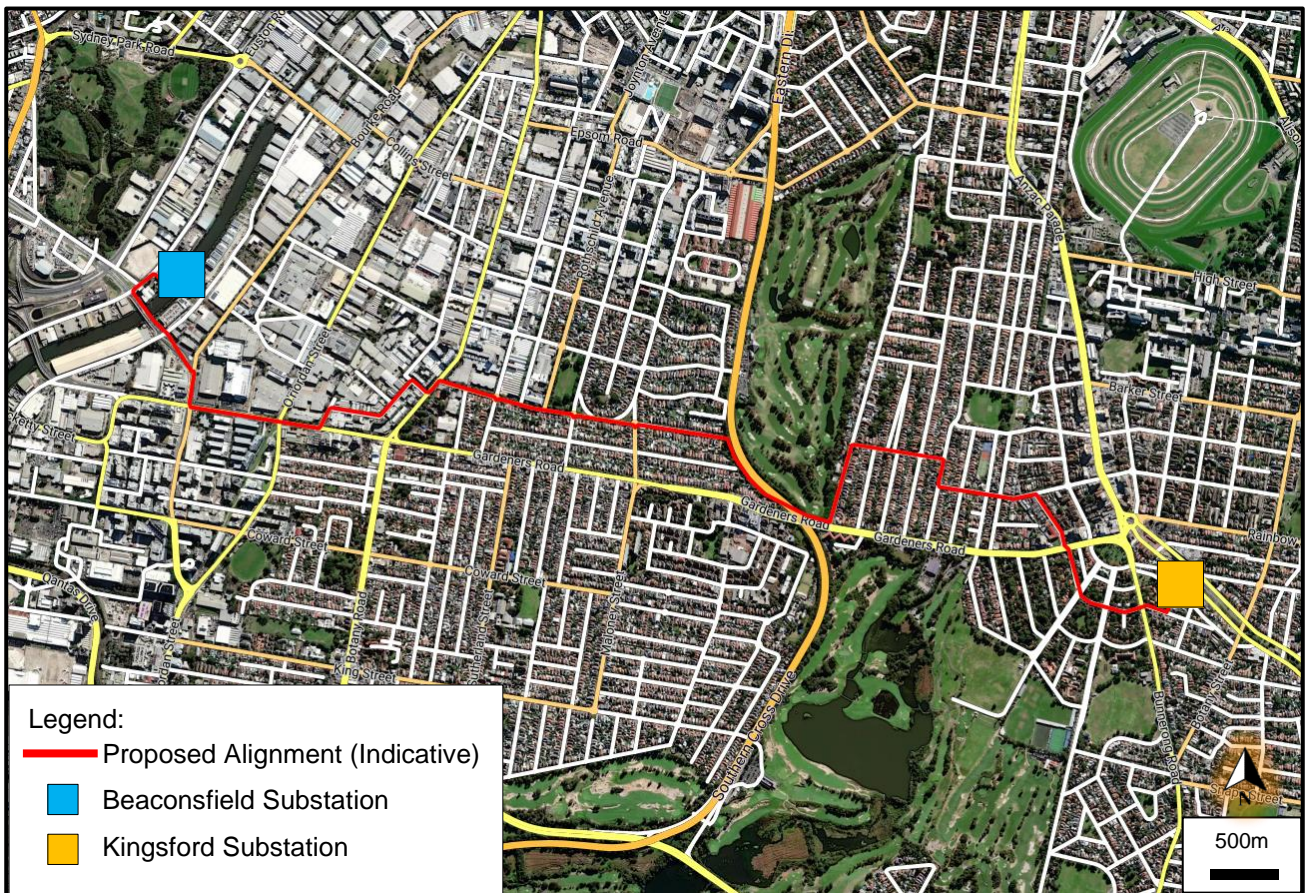
**Figure 1 - The Alignment Location & Aerial Image (extracted from MinView)**

The proposed alignment has a general NW-SE orientation and spans from Beaconsfield Substation (DP90878) along Burrows Road in Alexandria through to Kingsford Substation (DP1114019) on Anderson Street in Kingsford, in the City of Sydney and City of Randwick local government areas (LGA), respectively. The site location relative to the surrounding features is shown in Figure 1 below. The alignment primarily extends across urban areas, requiring underbores across major road crossings. The proposed alignment crosses over Alexandra Canal.

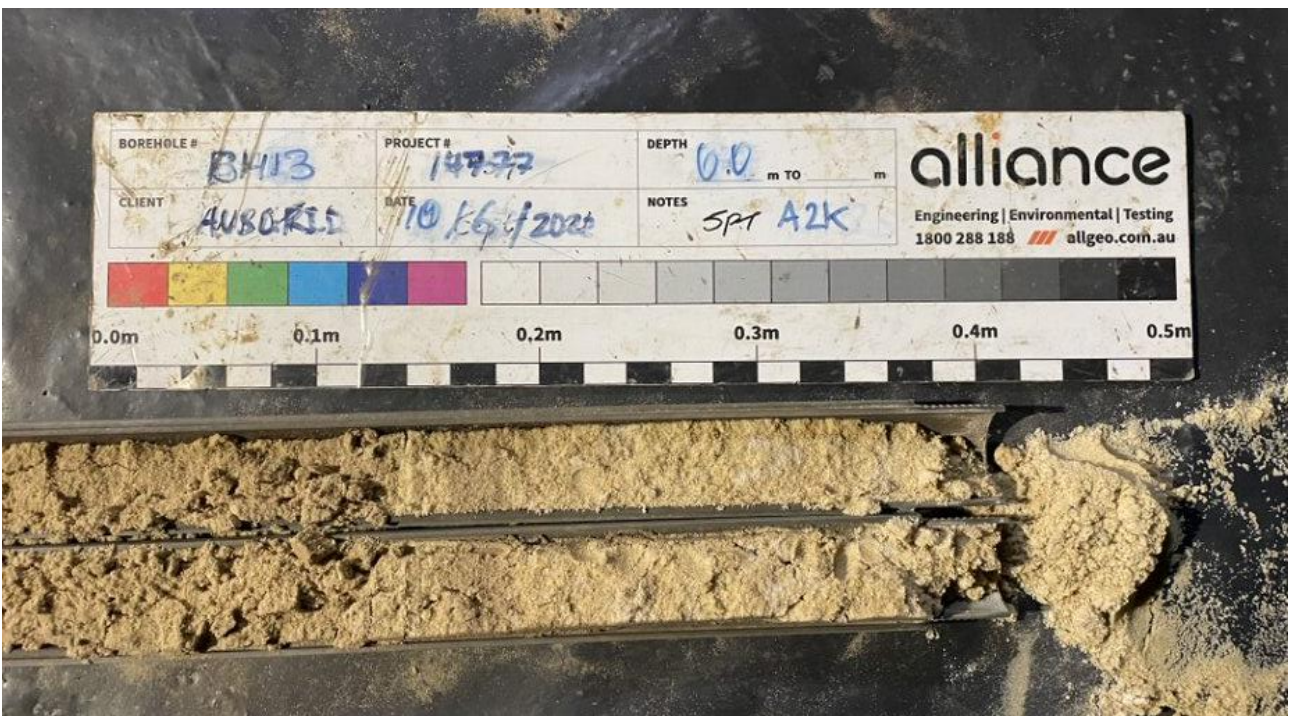
Photo 2 – SPT Split Spoon sample retrieved from borehole A2K-BH13 at 6.0m depth bgl

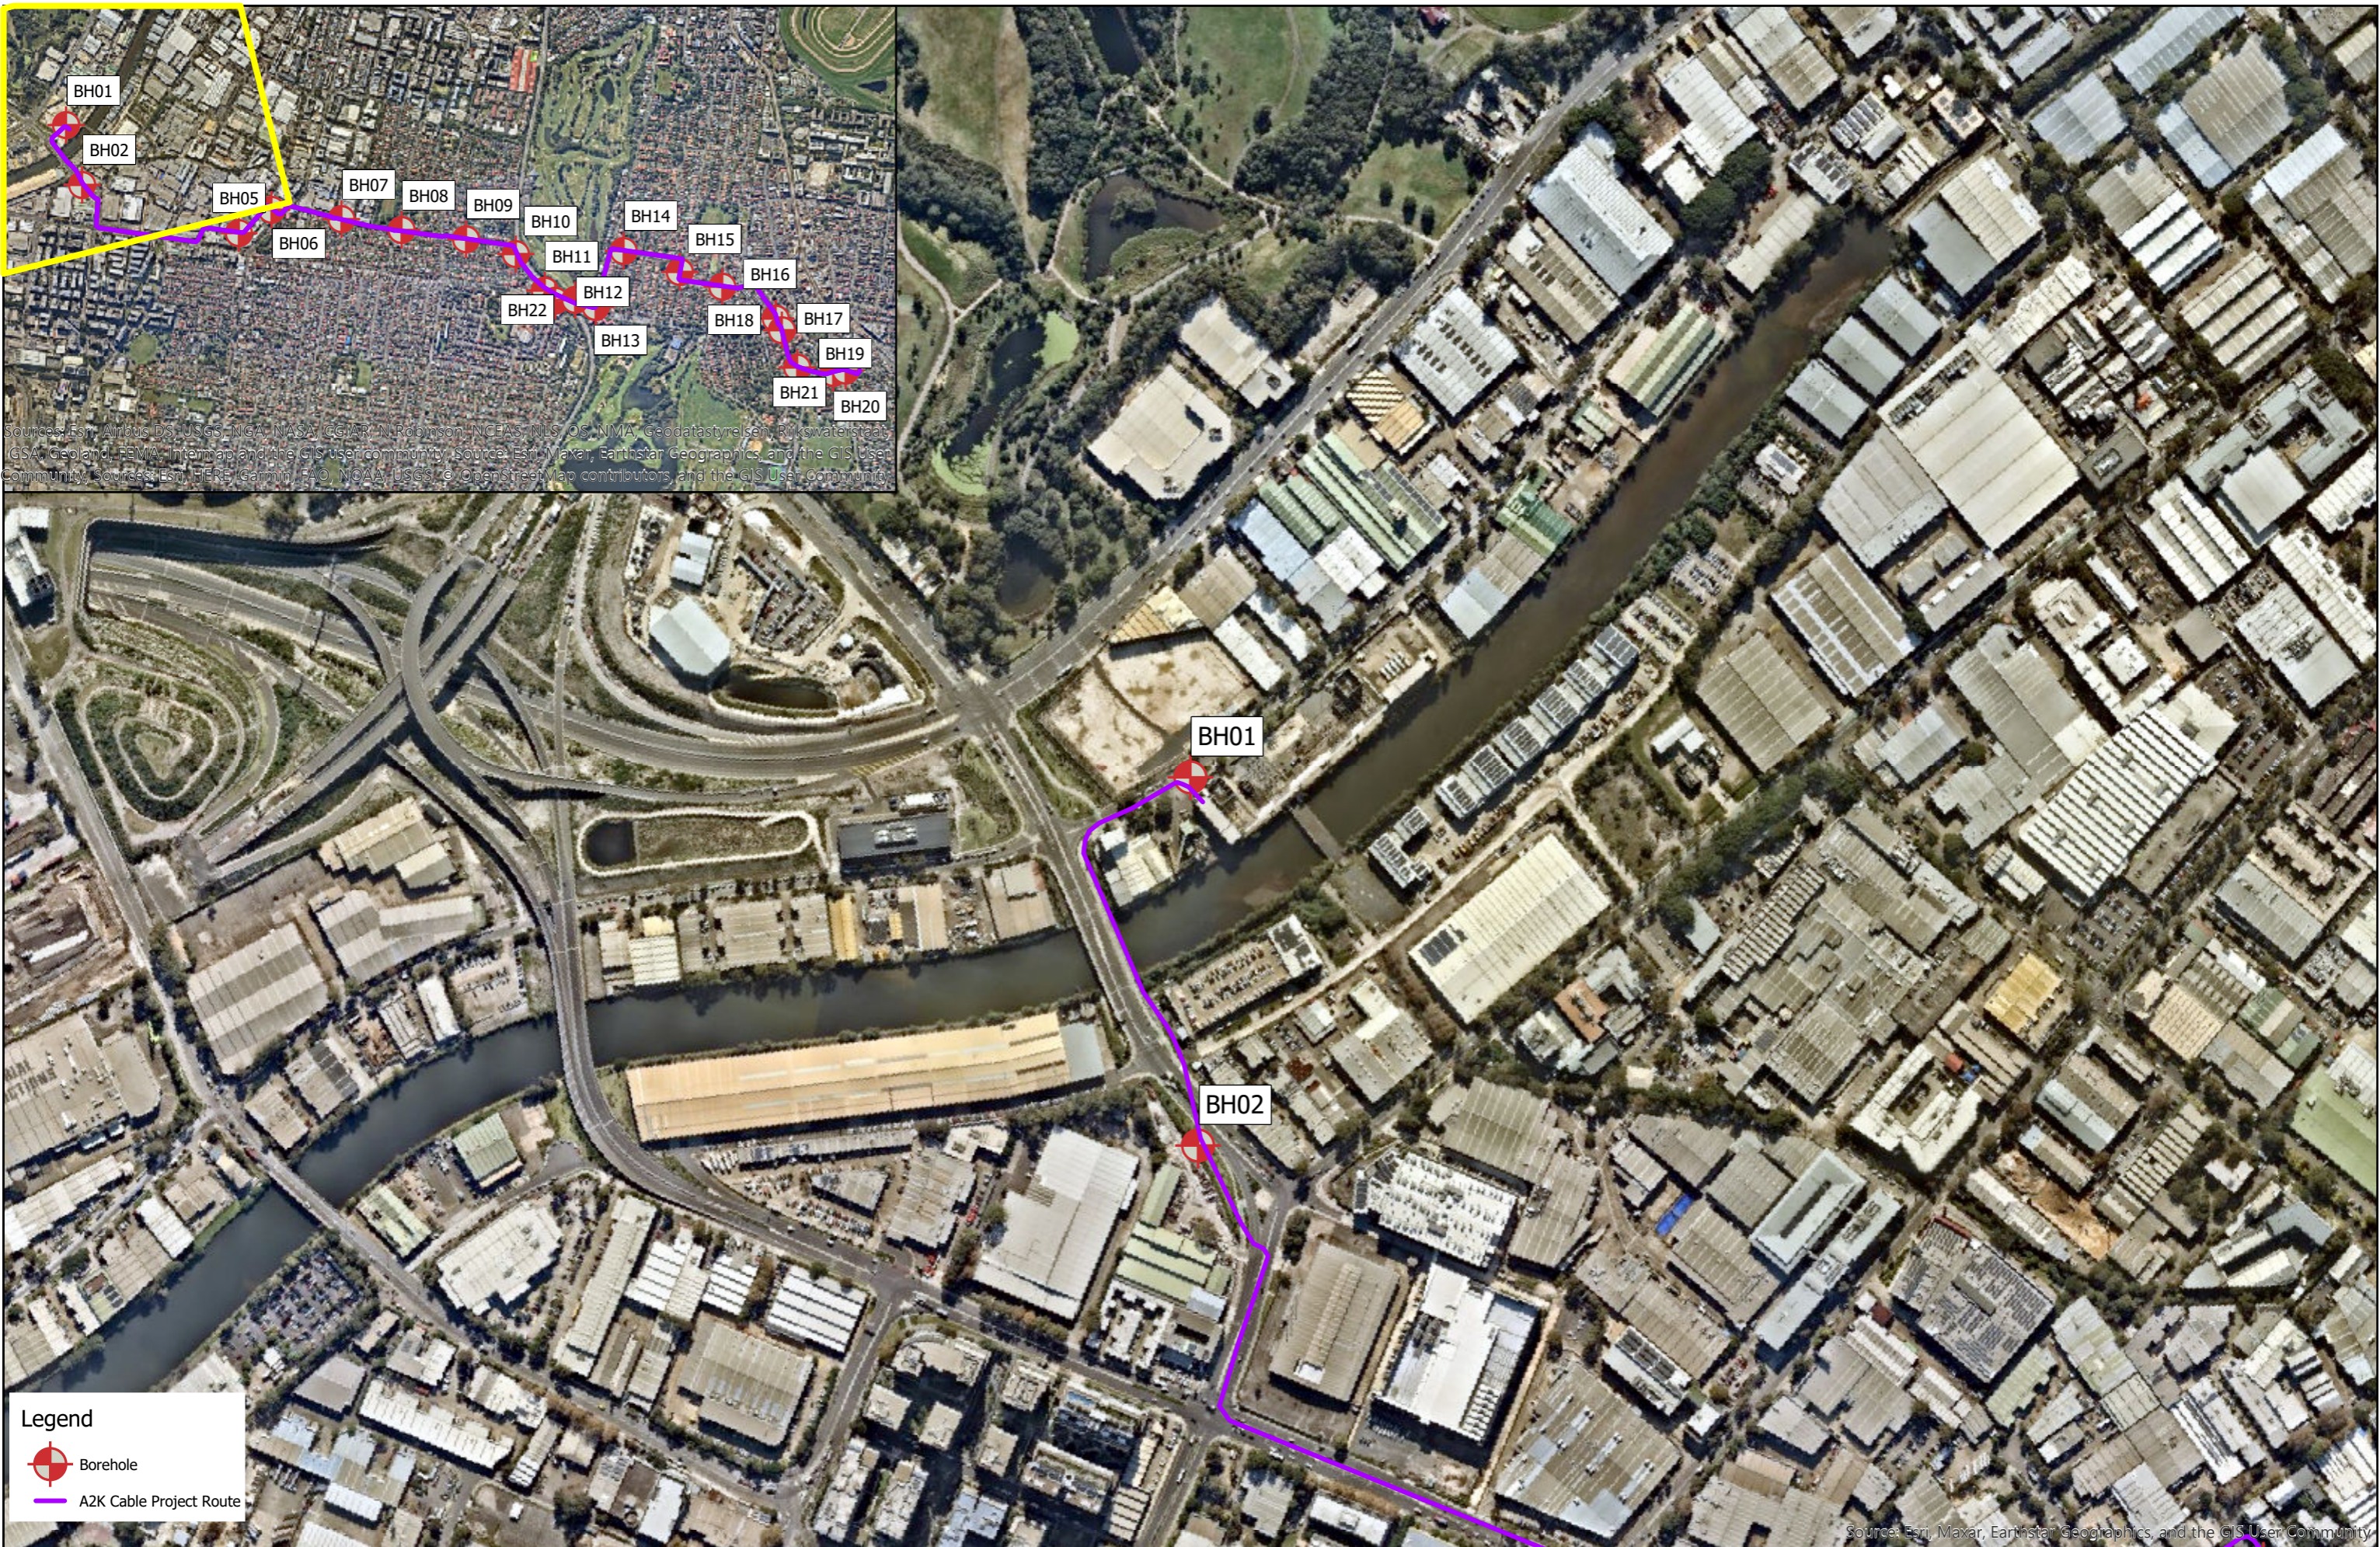
Figure Number:	14777-GR-1-2-A1
Figure/Drawing Date:	04/08/2022
Report Number:	14777-GR-1-2

**APPENDIX B – Geotechnical Investigation Plan (Drawing 14777-GR-1-2-A)**

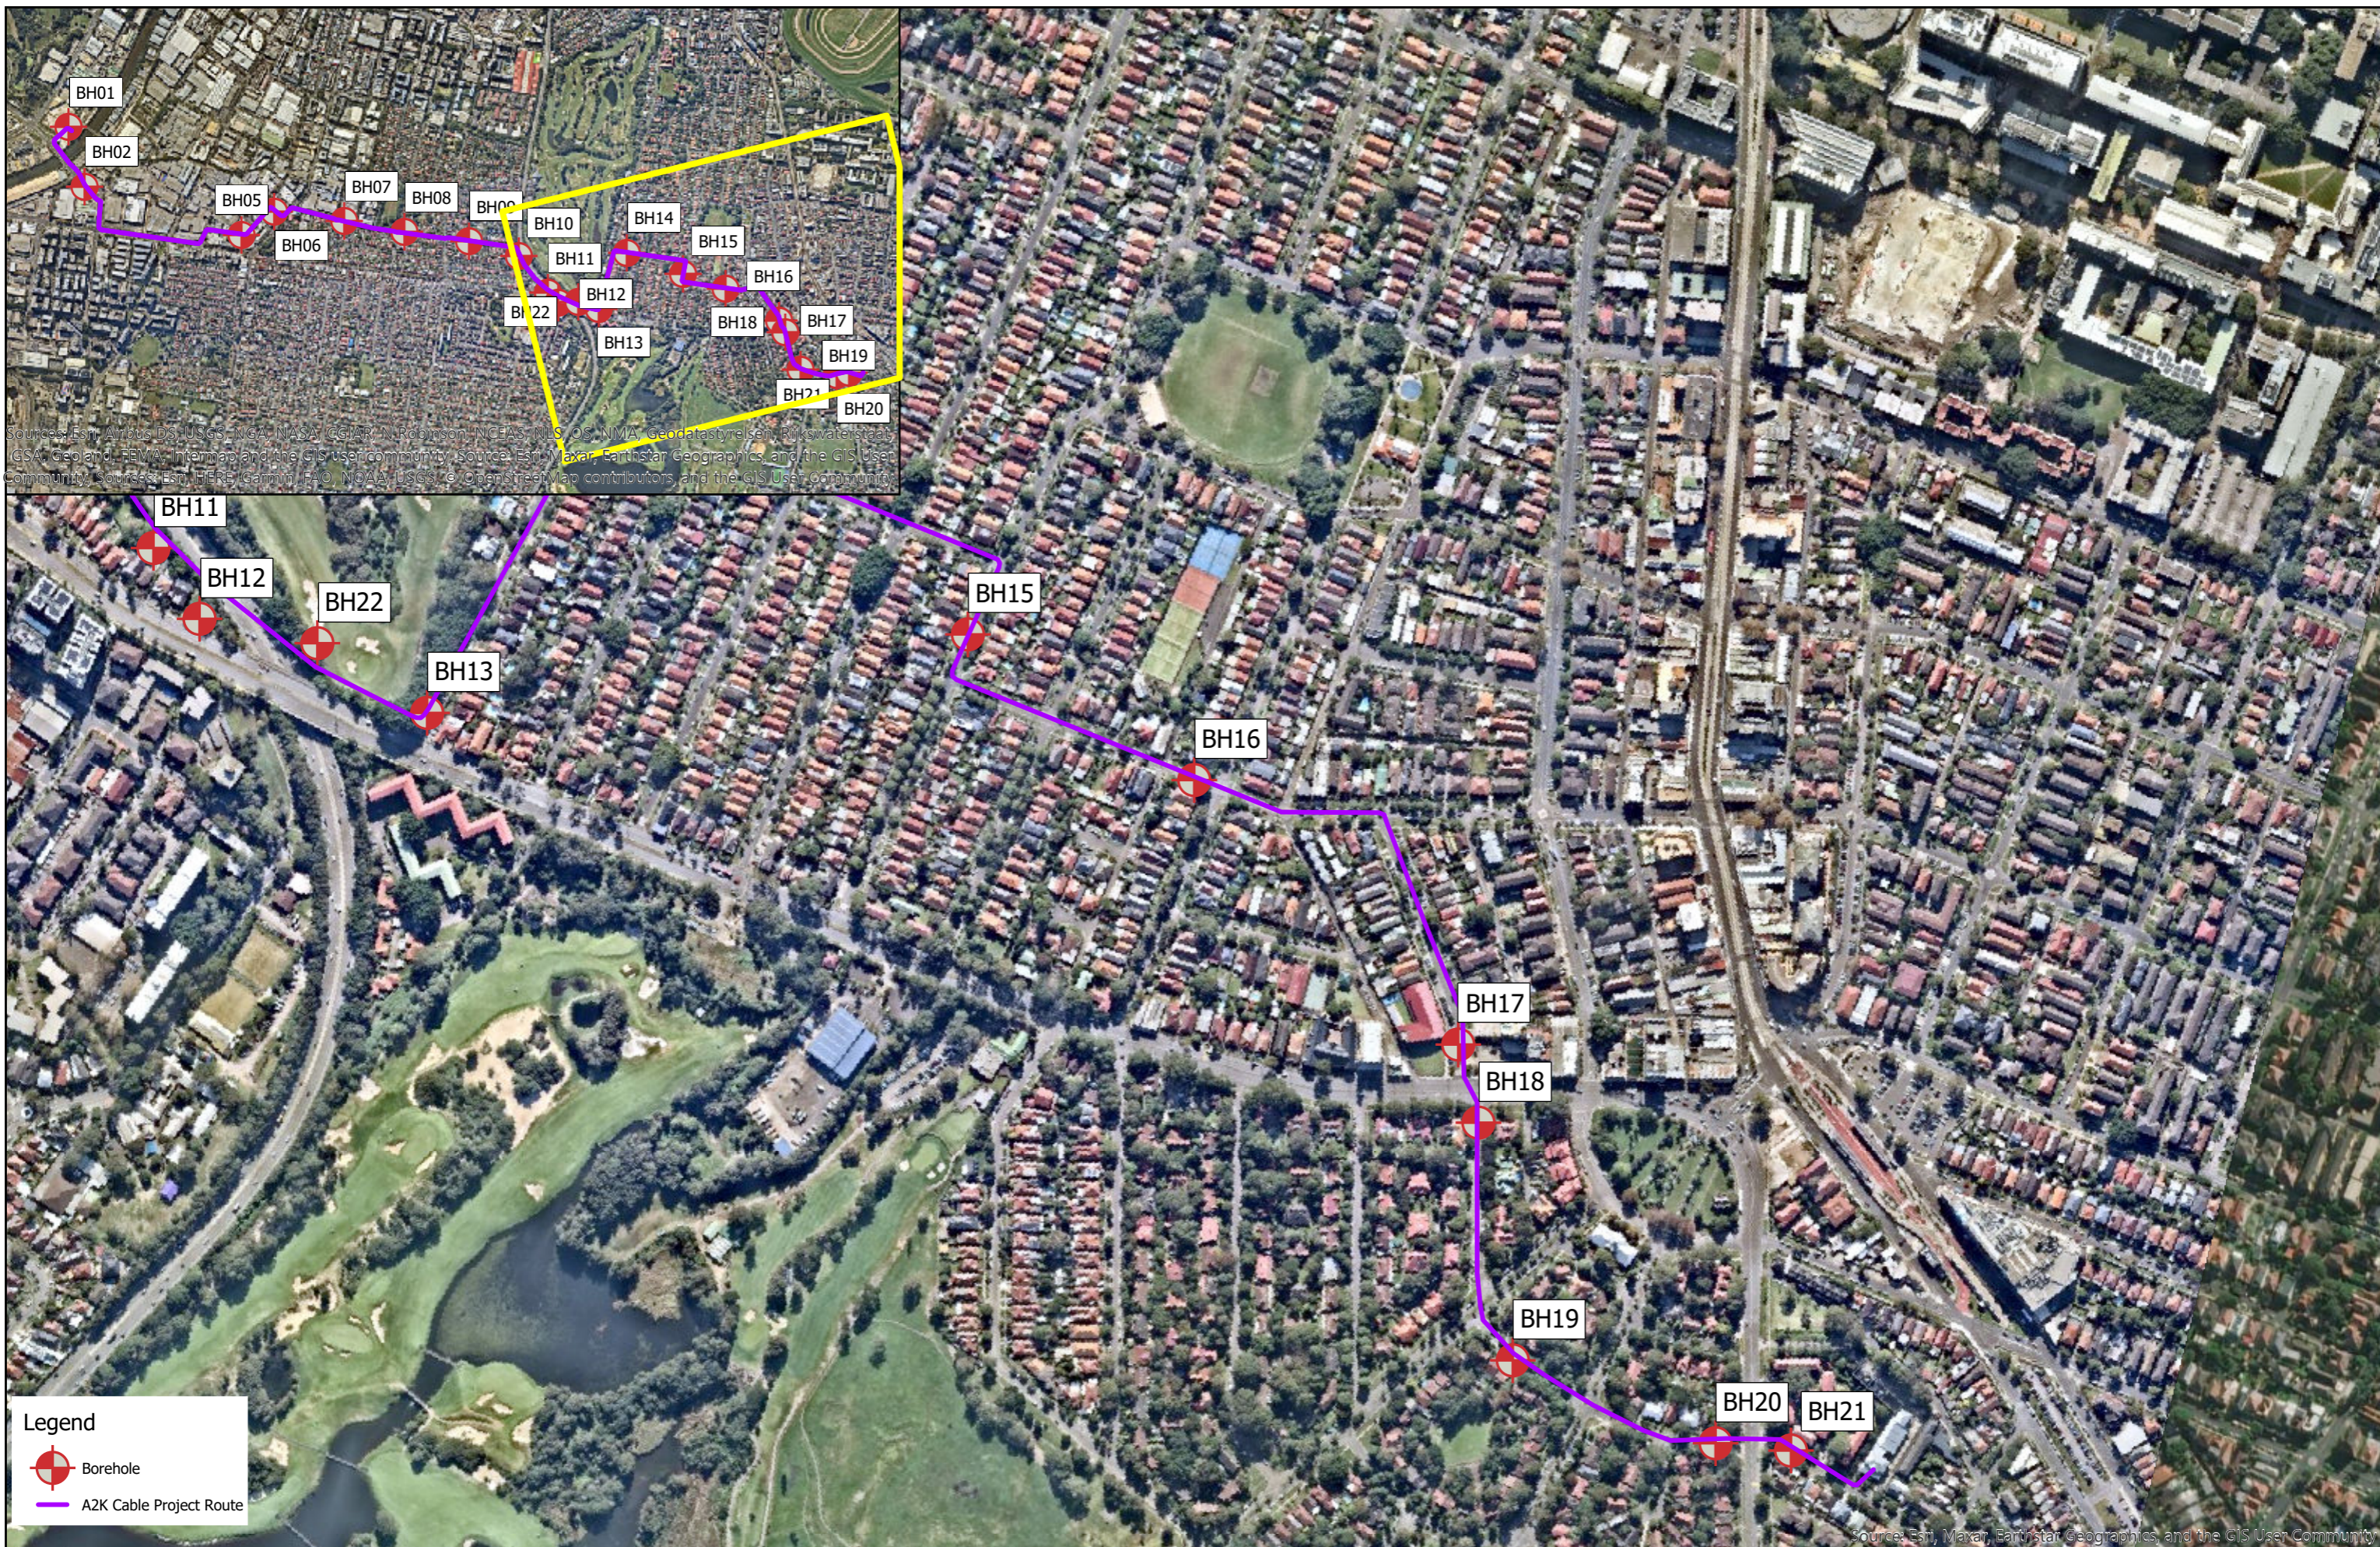
Figure Number:	14777-GR-1-2-A1
Figure/Drawing Date:	04/08/2022
Report Number:	14777-GR-1-2

Project Name:	Underground Cable Projects	
Project Location:	Alexandria NSW 1515 to Kingsford NSW 2032

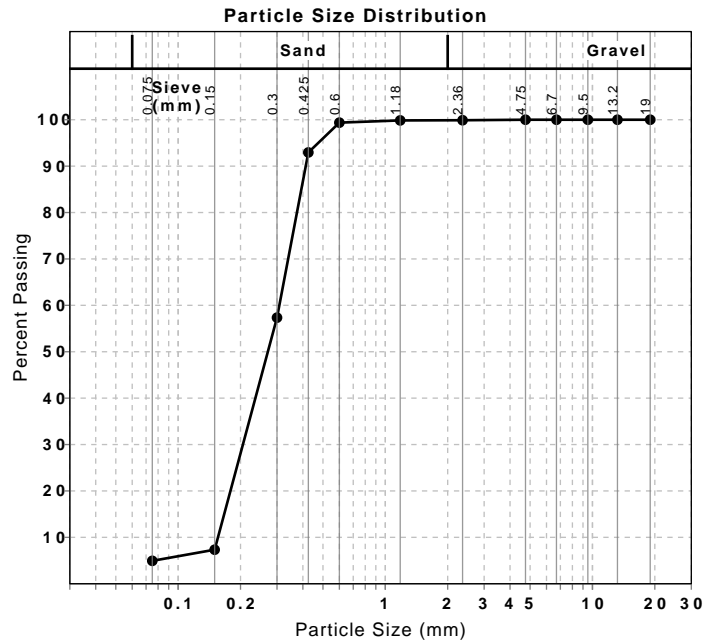
Particle Size Distribution (AS1289 3.6.1)		
Sieve	Passed %	Passing Limits
19 mm	100	
13.2 mm	100	
9.5 mm	100	
6.7 mm	100	
4.75 mm	100	
2.36 mm	100	
1.18 mm	100	
0.6 mm	99	
0.425 mm	93	
0.3 mm	57	
0.15 mm	7	
0.075 mm	5
