Arboricultural Impact Assessment

Site Address: Feeder 264 Replacement- Beaconsfield to Kingsford (B2K)

Client: Ausgrid

Date: July 2022

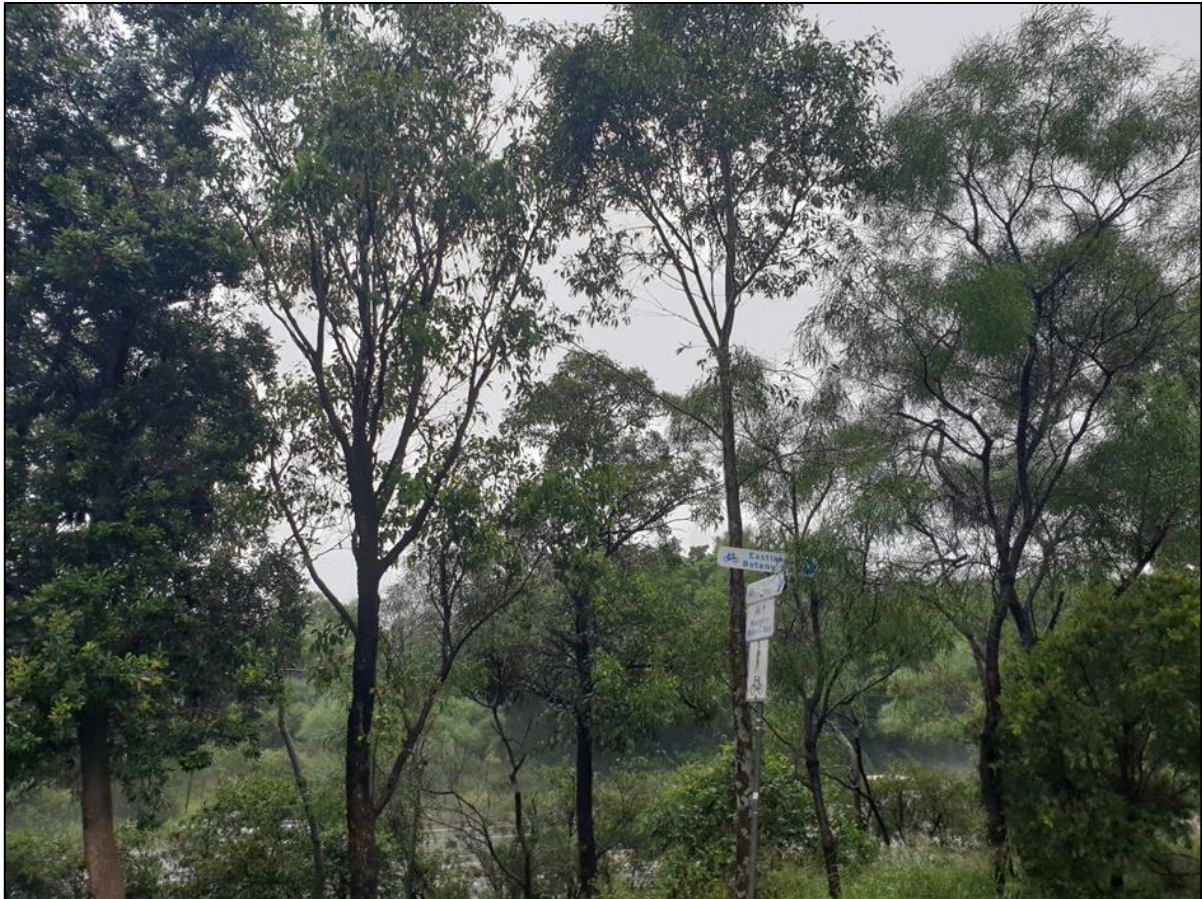
Figure 2 Small trees will be removed for the send/receive pit in Southern Cross Drive Reserve

The removal of young Eucalypts is supported subject to the provision of replacement plantings of the same species once works have been completed, the removal of *Acacia saligna* which is generally considered to be an environmental weed species will have a positive impact on biodiversity values in the locality. Several other *Acacia saligna* may require pruning to allow access by heavy machinery from Gardners Rd during the works, this is a minor environmental impact.

That ten (10) immature *Eucalyptus species* adjacent to the Gardners Road overpass are approved for removal subject to the planting of replacement trees of the same species at the completion of works.

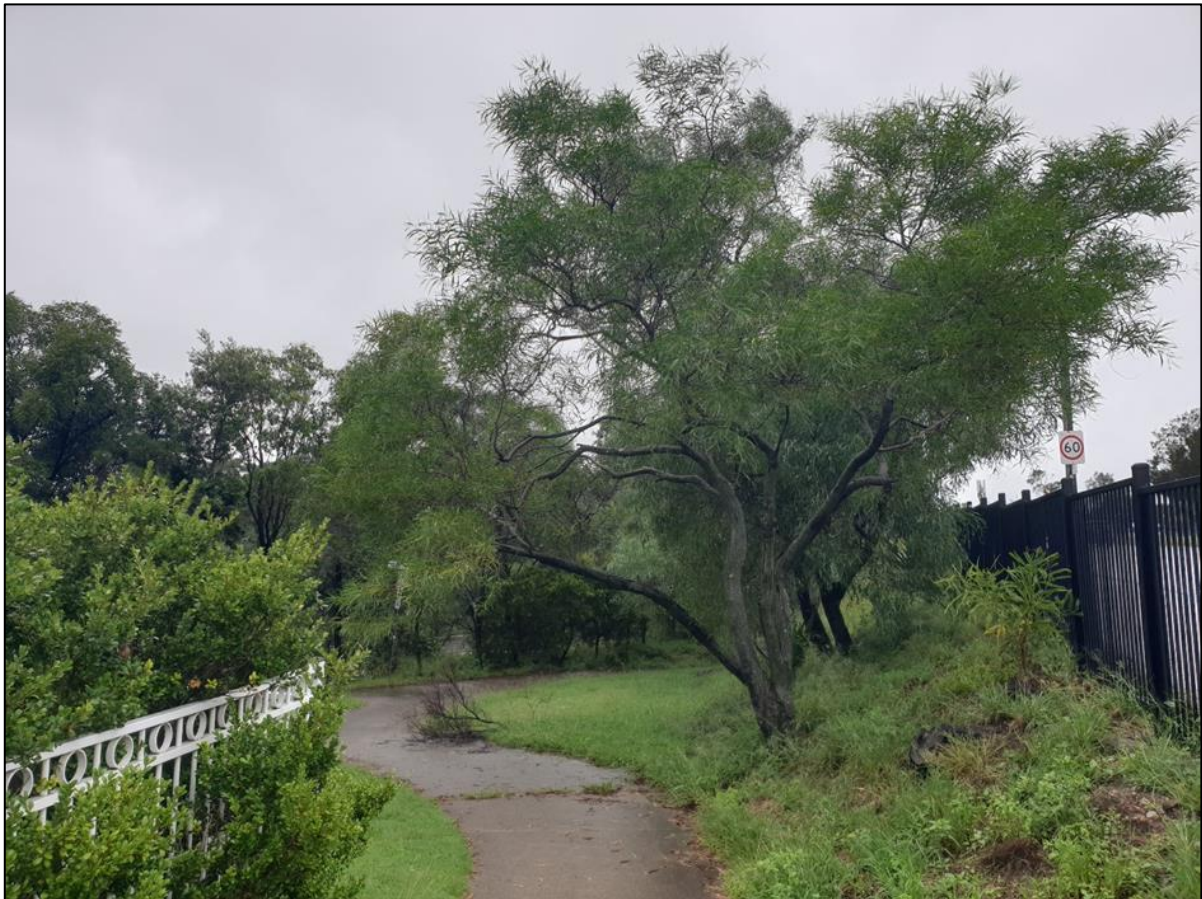
Figure 3 *Acacia saligna* west of Gardners Rd may require pruning to provide access
