Arboricultural Impact Assessment

Site Address: Feeder 265 Replacement Matraville to Maroubra (M2M)

Client: Ausgrid

Date: May 2020

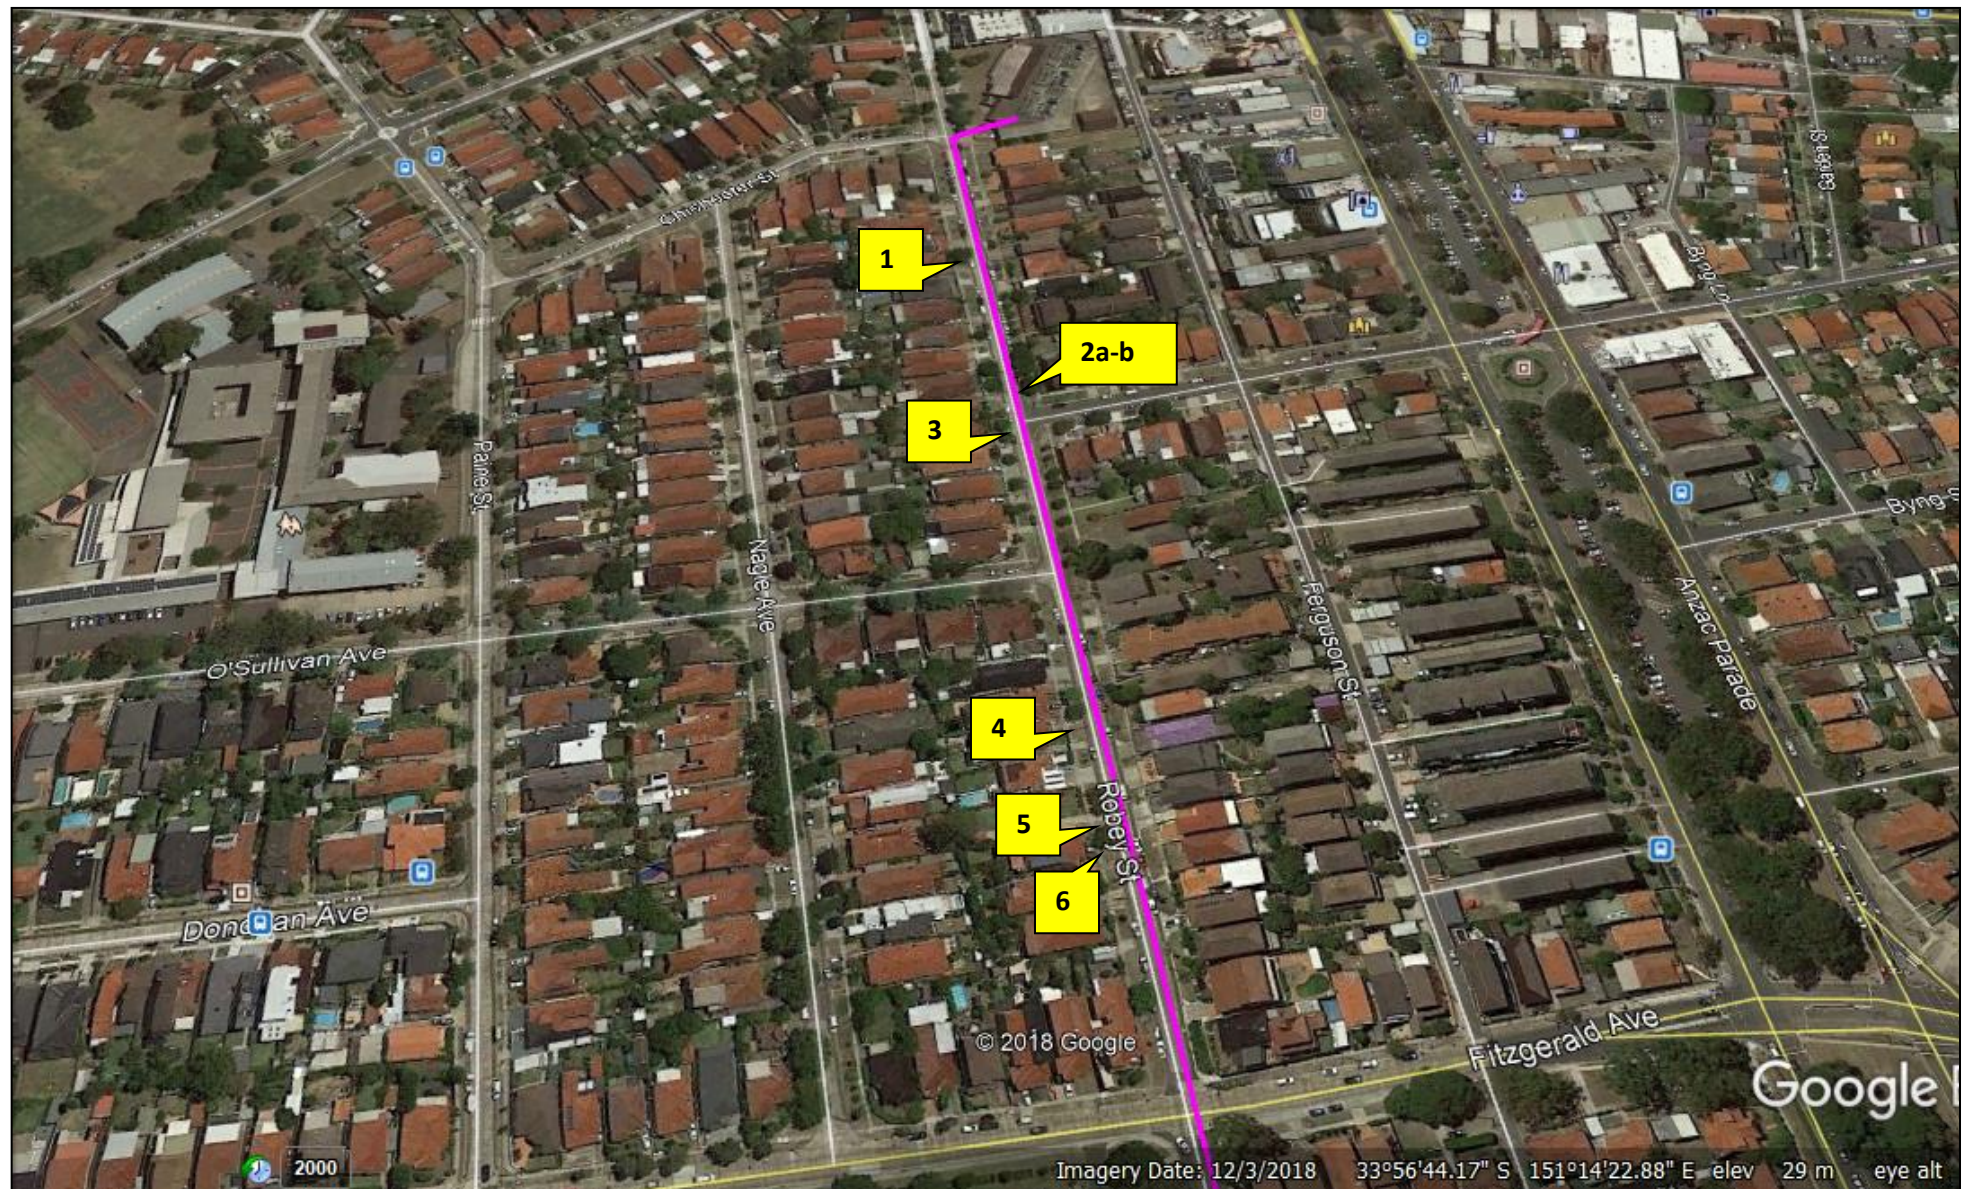
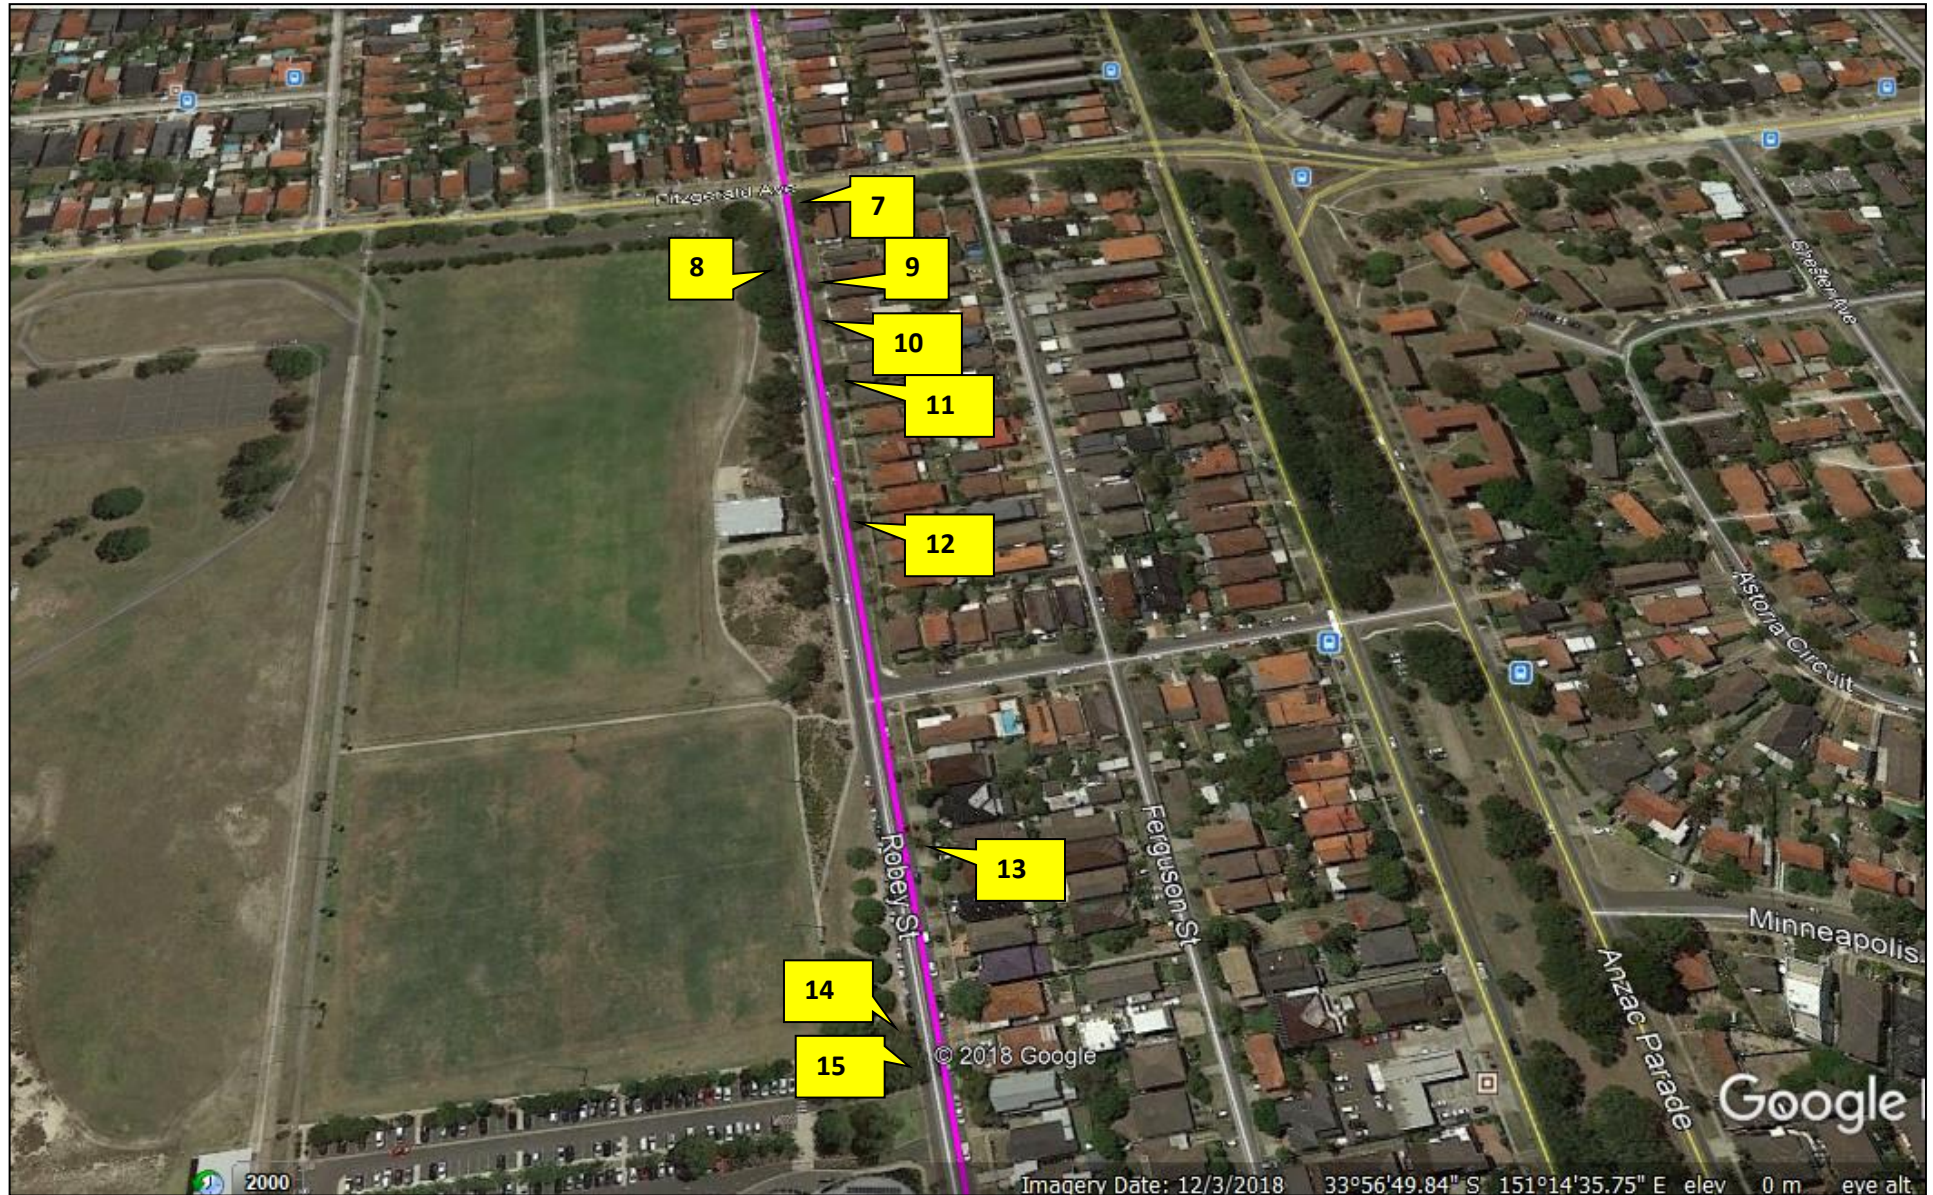
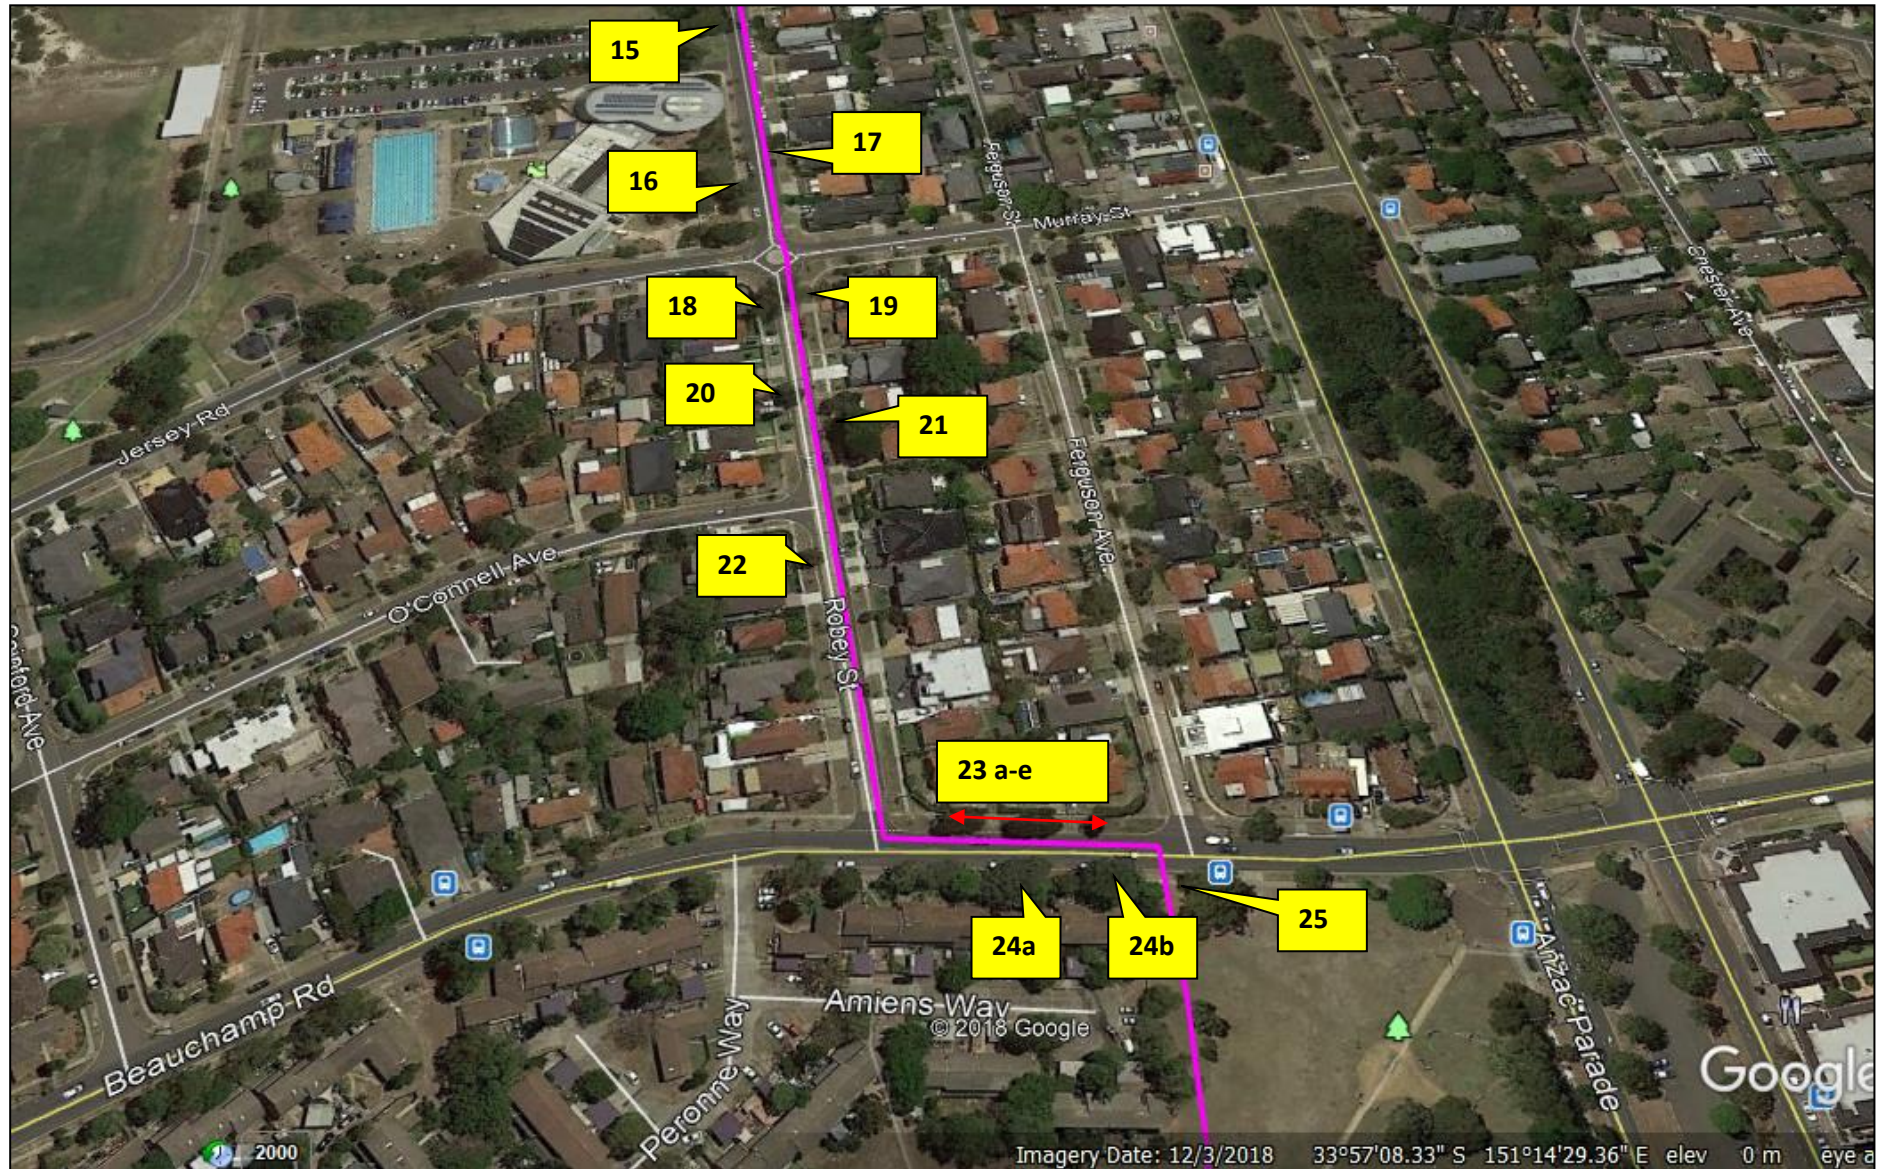
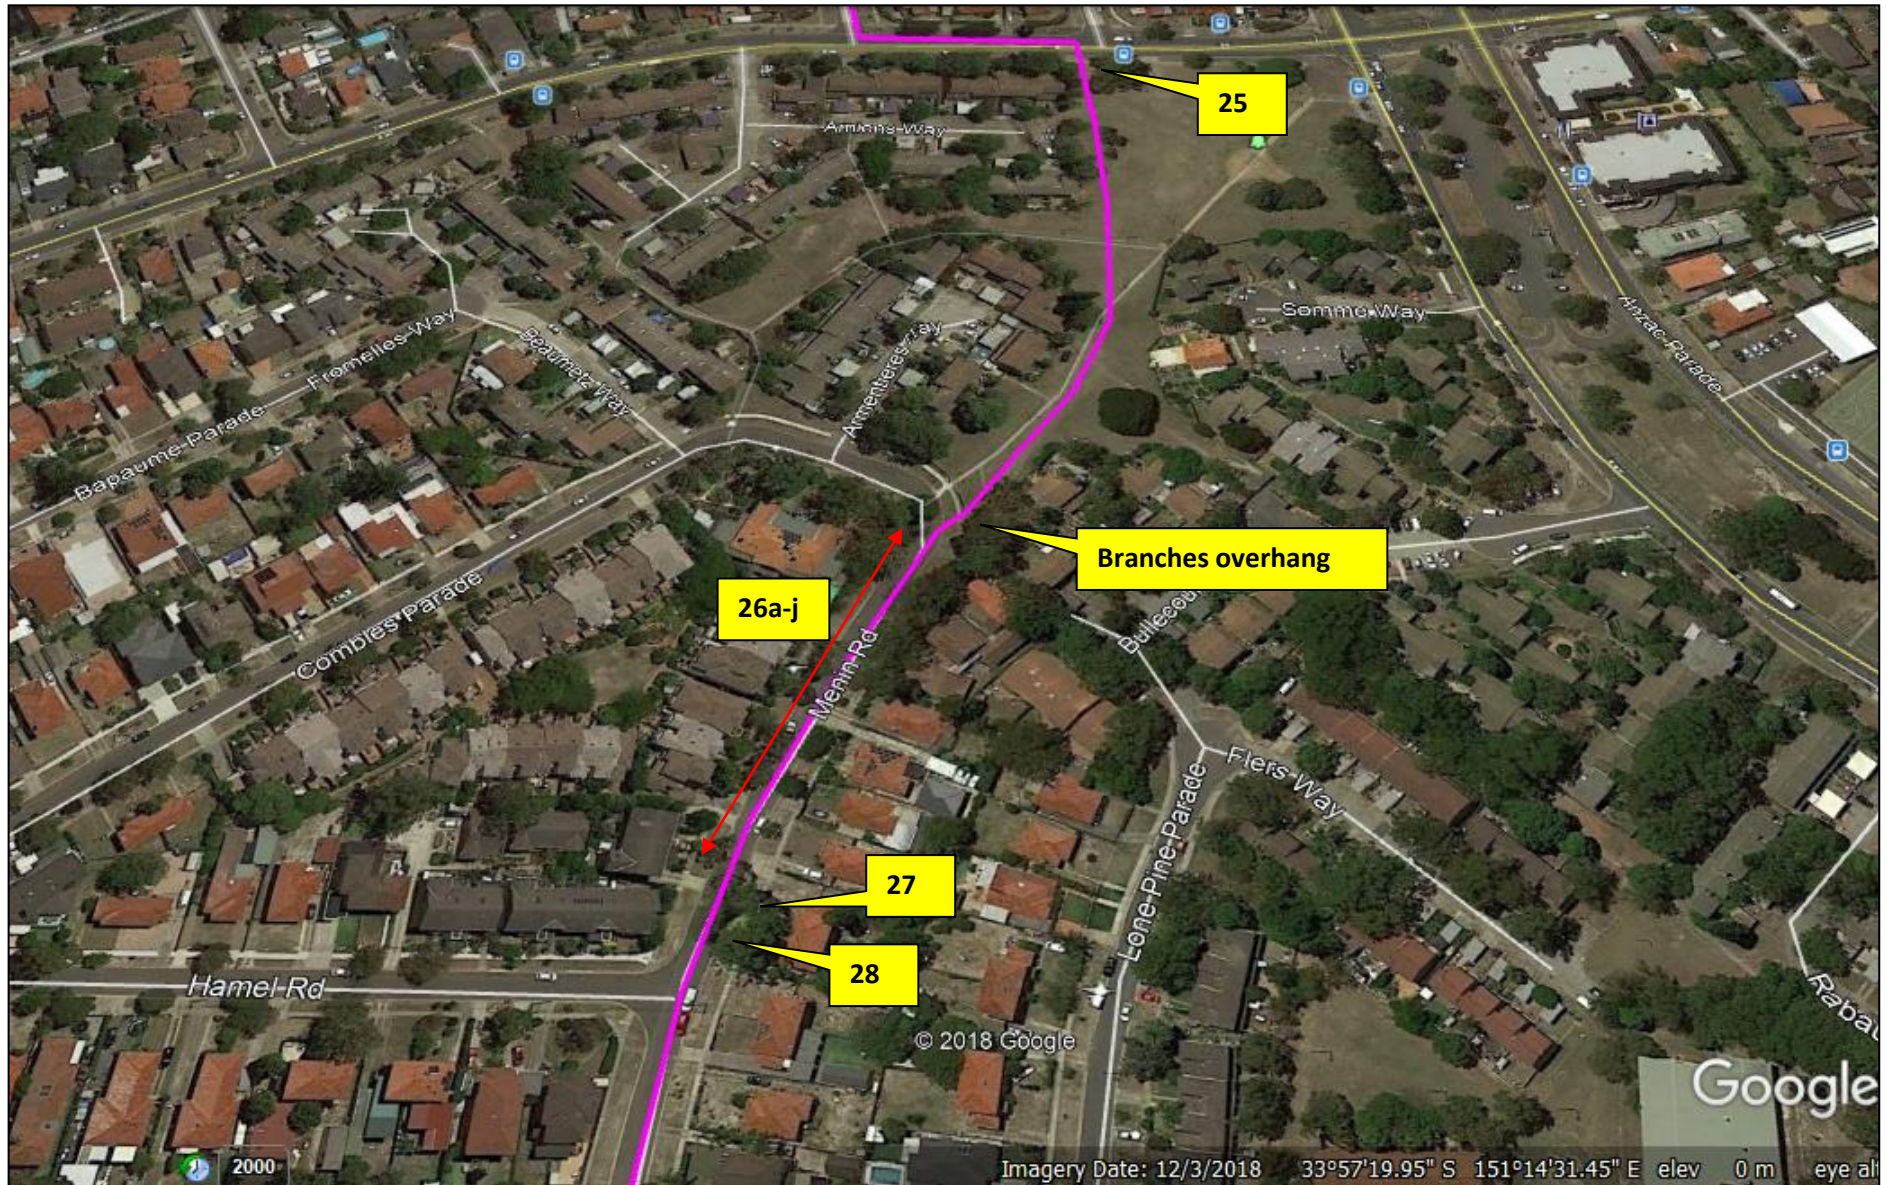
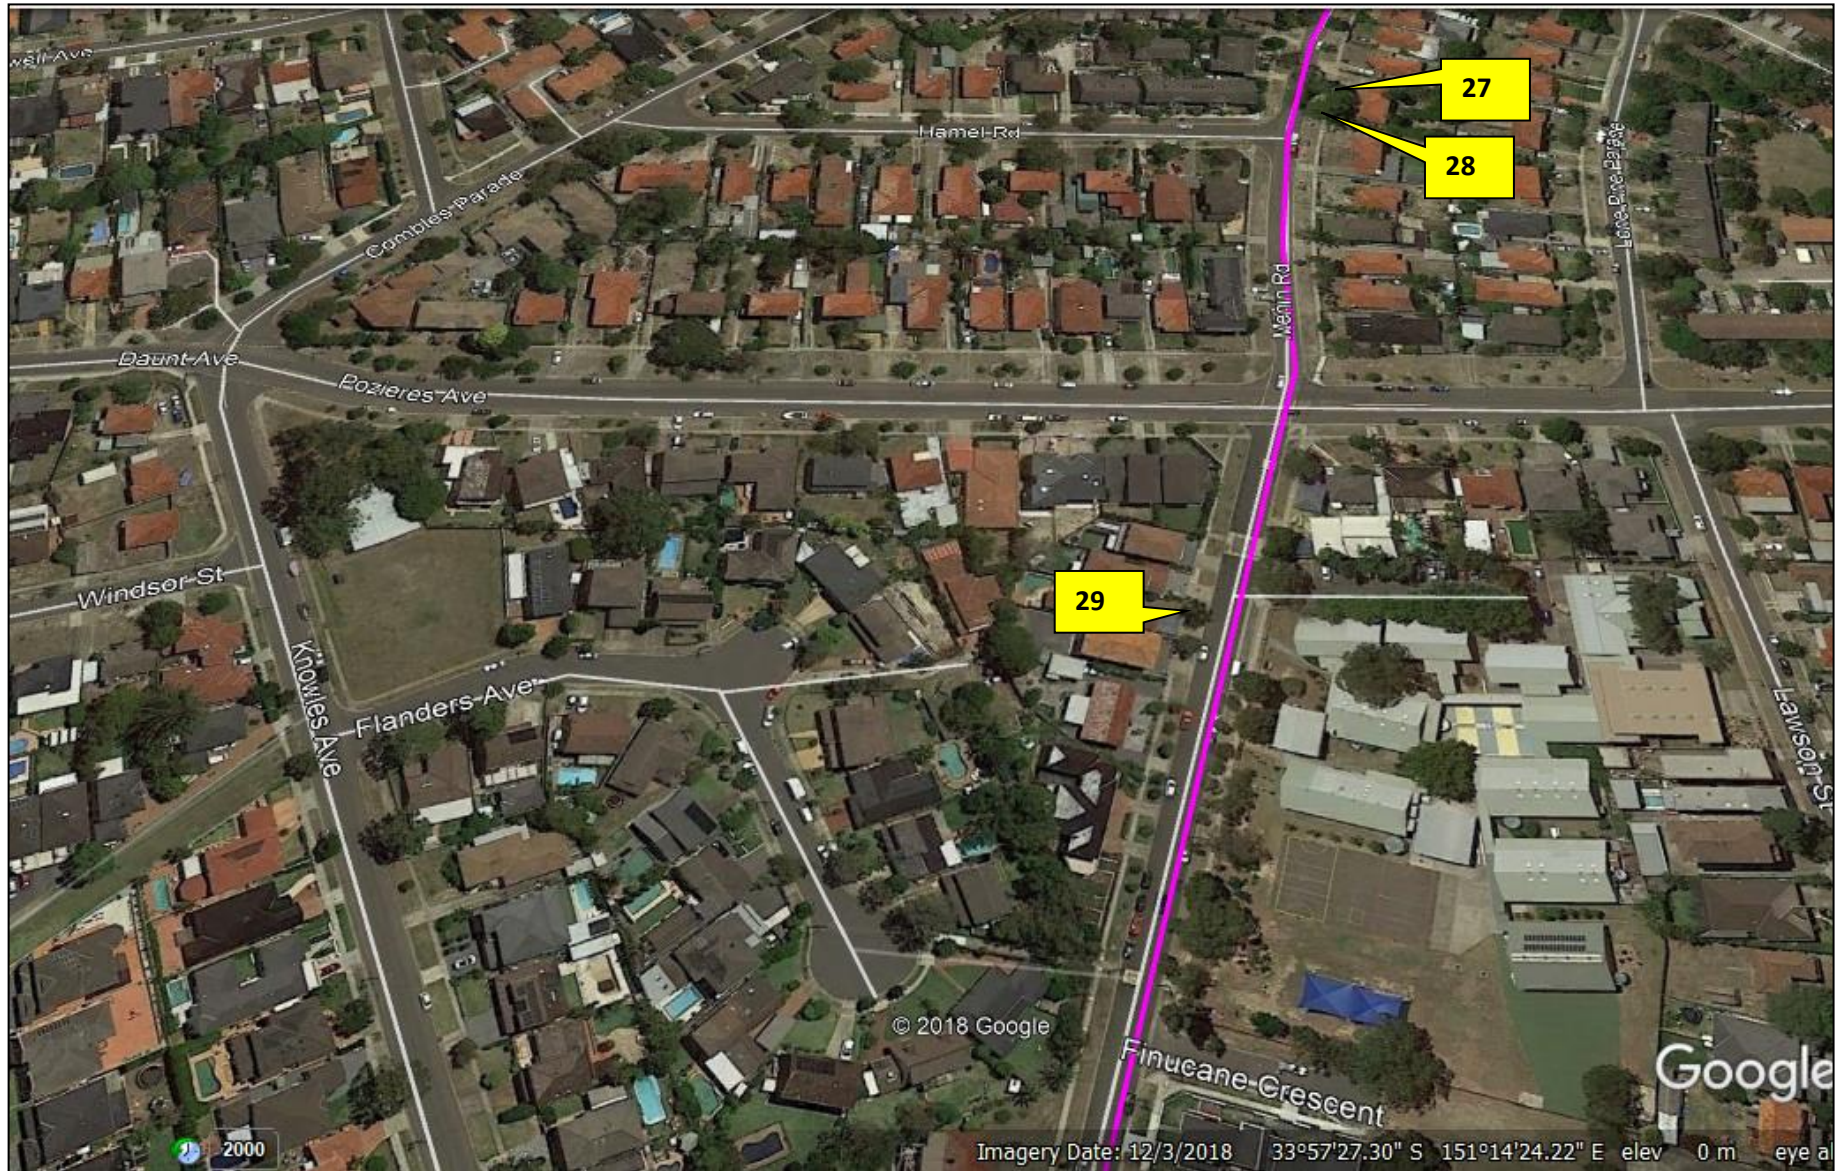
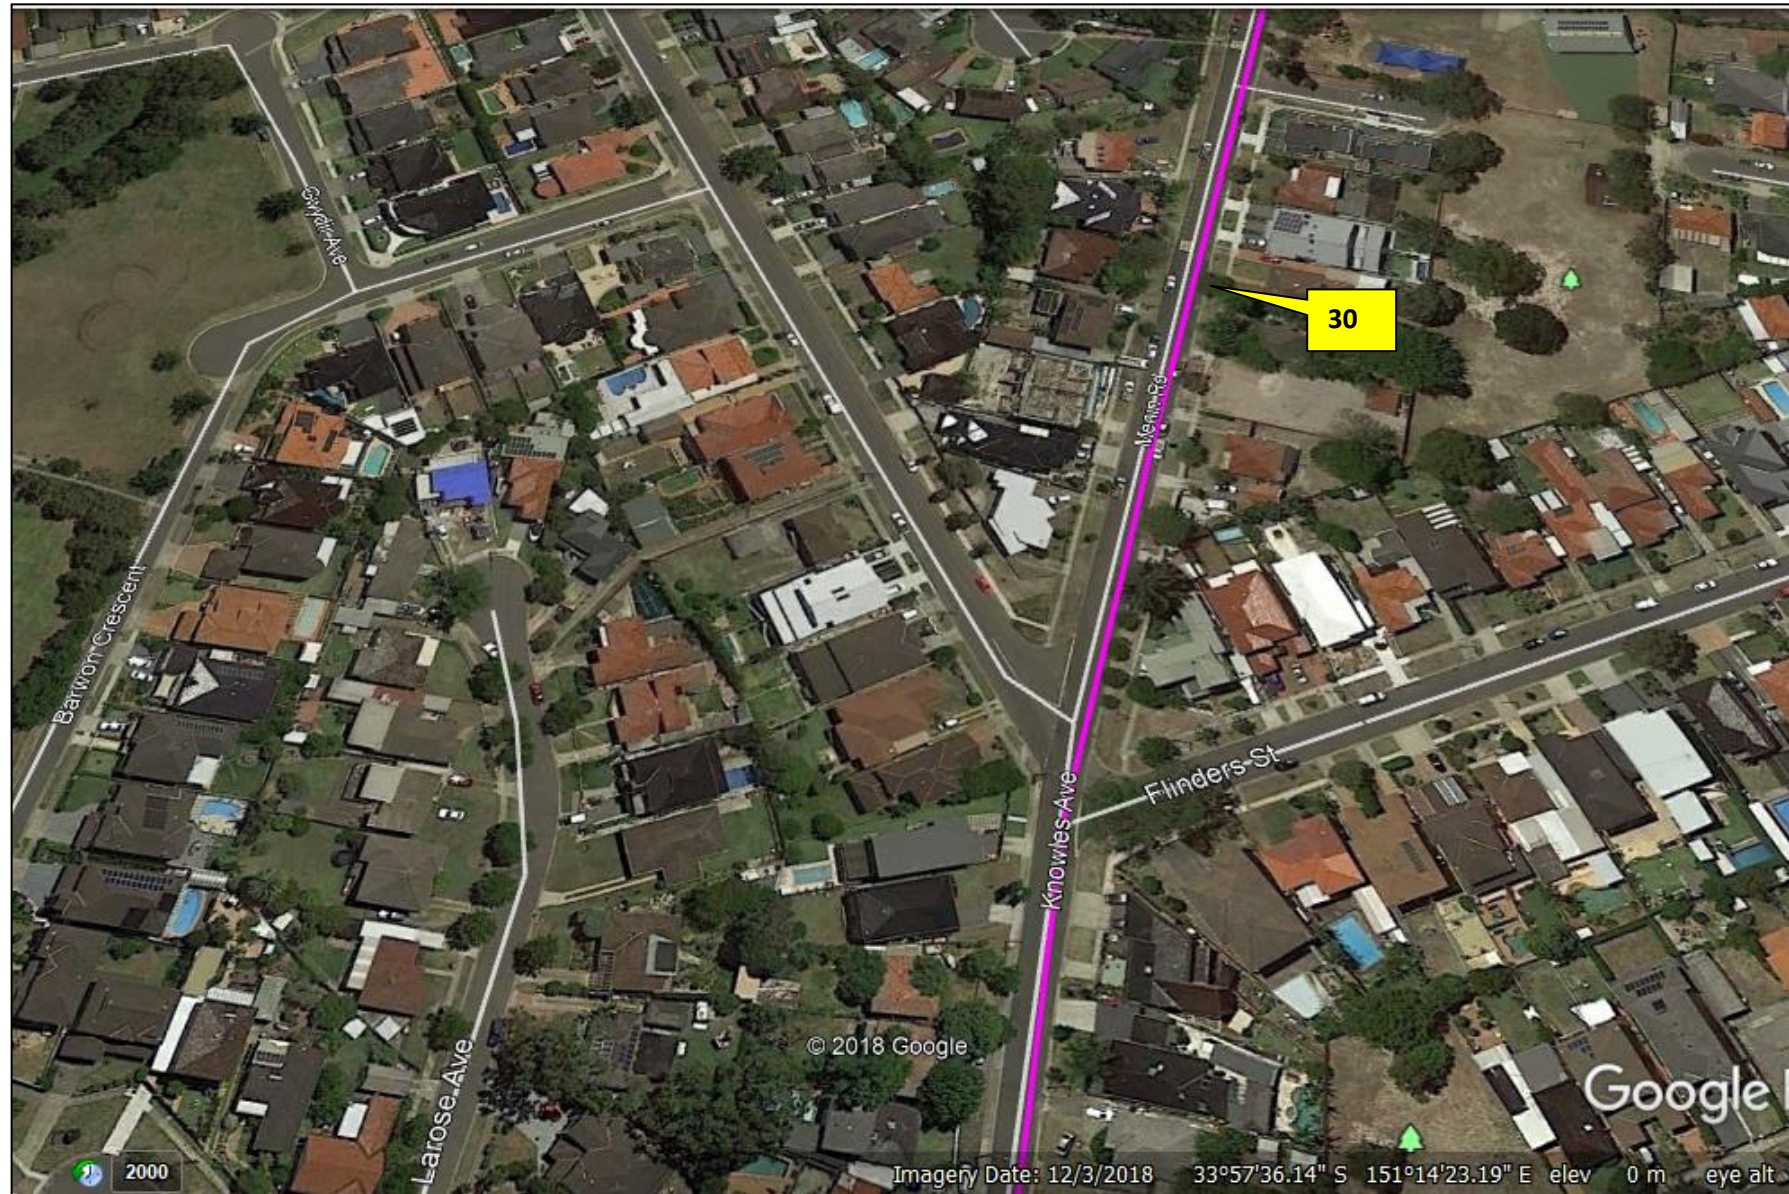
10.2 Tree Location Plans –Sheet 1

Trees subject to assessment have been marked on the aerial photomaps extracted from the .kmz file provided.

A .kmz file of the proposed route (Appendix 10.2) has been provided by Ausgrid and has been used as reference throughout the report.

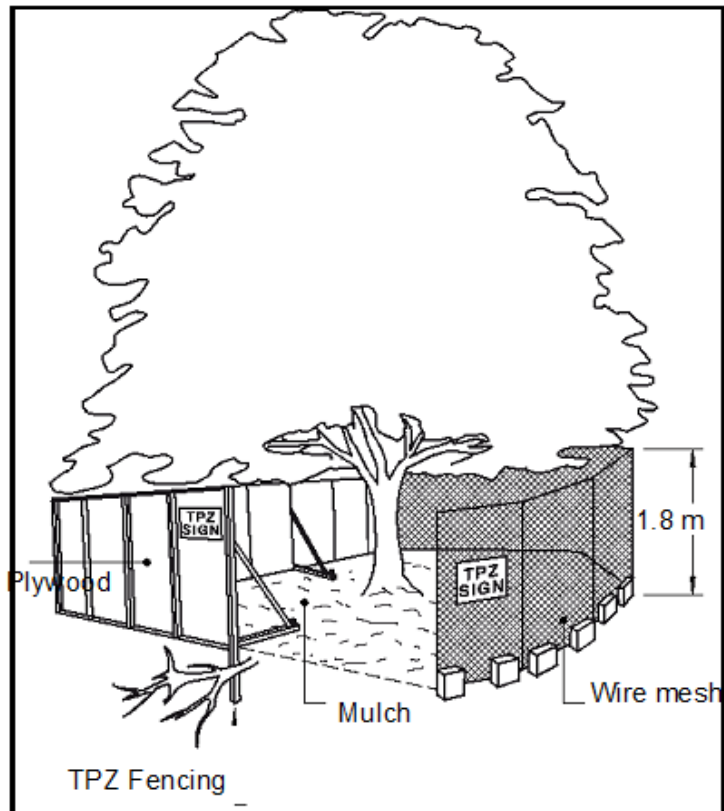
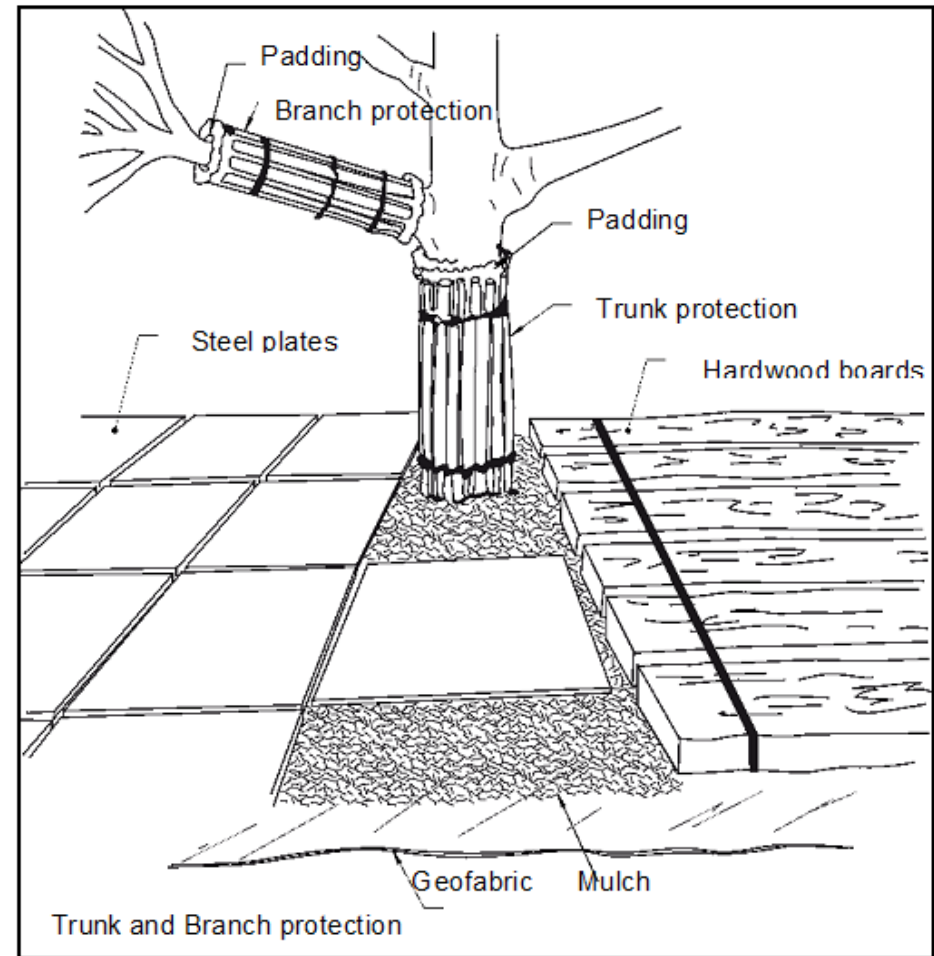
10.3 Tree, Trunk and Branch Protection Methods (Source AS4970-2009)

Prior to the commencement and for the duration of the works, the trunks of the subject trees are to be protected from unintended impacts by the observance of the respective TPZ setbacks which will be monitored in accordance with Ausgrid standard NS174c. Where required the trunks and/or branches of the retained trees will be protected by armouring as detailed in Section 4 of AS4970 (Appendix 12.4)
